Report on Case No CEP-25-5661

Allegations concerning damages in the Bartolott Crypt at St John's Co-Cathedral.

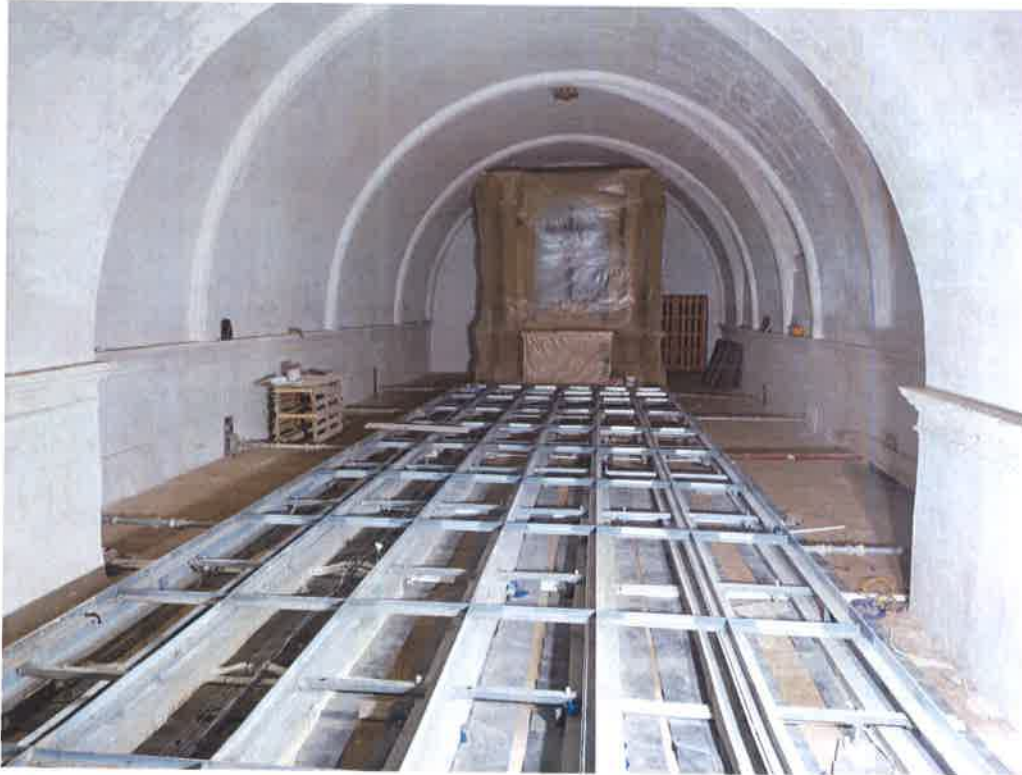
This investigation included a site inspection in the Bartolott Crypt where representatives of the Superintendence of Cultural Heritage, of the St John's Co-Cathedral Foundation, Project Architects and Project Managers were present. During this inspection, the raised floor steel

structure and all the flagstones were in place and the sides were clean of any gravel.

Photograph taken by the Commissioner during the site inspection.

The removal and reinstatement of the flagstones that had subsided was carried out in line with the approved Works Method Statement and all the flagstones that were reinstated were adequately recorded on plan for future reference.
